Servicemitteilung zu AE 2990 AFS v. 21.2.2011

Service Note 2990 AFS issued 21. 2. 2011

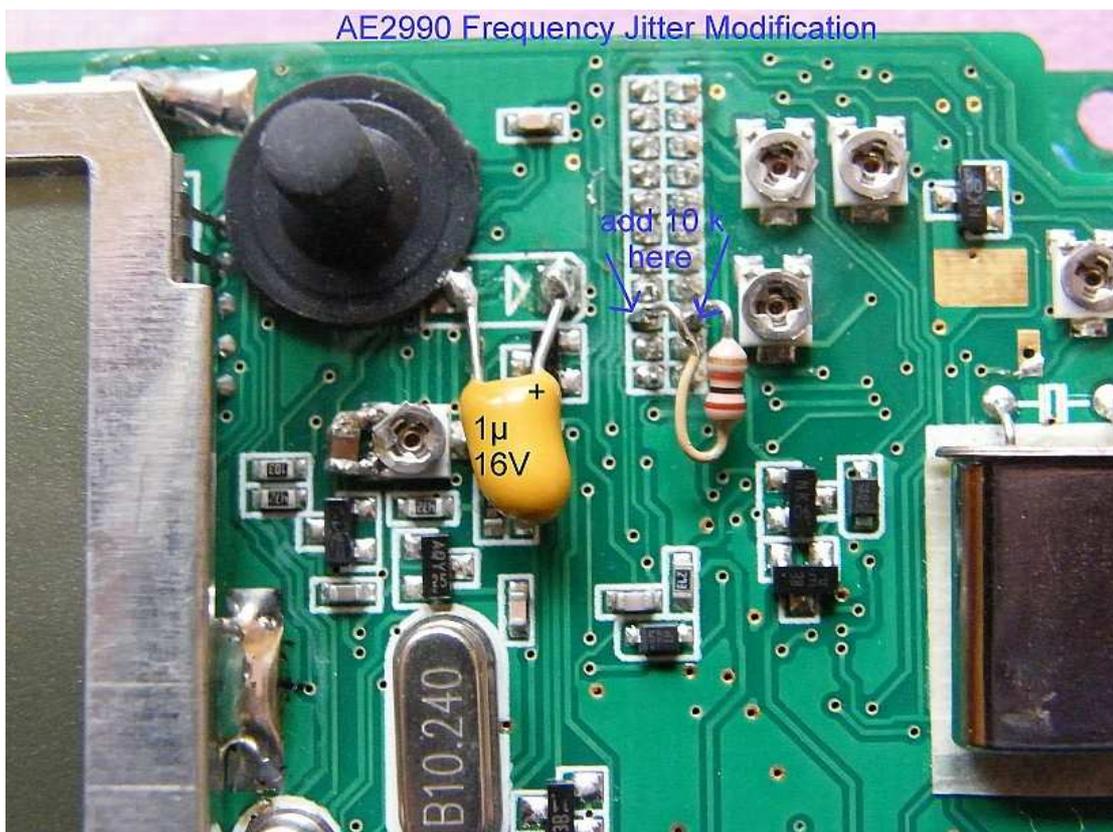
Bei einigen Geräten der ersten Produktionsserie Dezember 2011 wurde bemängelt, dass die Sendefrequenz in SSB bei starker Modulation einen kurzen Einschwingvorgang vollführt. Dieser äußert sich darin, dass z.B. beim Pfeifen in das Mikrofon der Pfeifton während der ersten 10..20 Millisekunden etwa 100..200 Hz neben der Frequenz liegt. Eine Gegenstation wird den Ton als nicht konstant bezeichnen, er ist zuerst neben der Frequenz und wird dann sauber. In Foren wird der Effekt von den Usern als „Eiern“ beschrieben, technisch trifft der Begriff Jitter den Sachverhalt besser.

Ursache: Der Lastwechsel der ansteigenden Sendeleistung bei SSB beim ersten Sprechen bewirkt eine unerwünschte HF Rückwirkung auf den VCO. Die Phasenregelschleife erkennt das als Frequenzablage und regelt nach. Das Regelverhalten reagiert dabei kurzzeitig wie ein Überschwingen.

1. Änderung eines Standard SMD Elkos von $2.2\mu\text{F}$ in einen Tantal-Elko $1\mu\text{F}$ (gelb) in der Phasenregelschleife nach obenstehendem Foto.

2. Zusätzlich kann man auch noch einen **zusätzlichen Widerstand** von ca. $10\text{ k}\Omega$ über die im Bild gezeigten Kontakte des Pfostensteckers (3. Kontaktebene von unten gerechnet, entspr. R 203) legen.

Dieser Widerstand wird aber nicht empfohlen, wenn jemand Wert auf gutes Einrasten auch im untersten und obersten der 400 Kanal-Bänder Wert legt (ggf. ausprobieren).

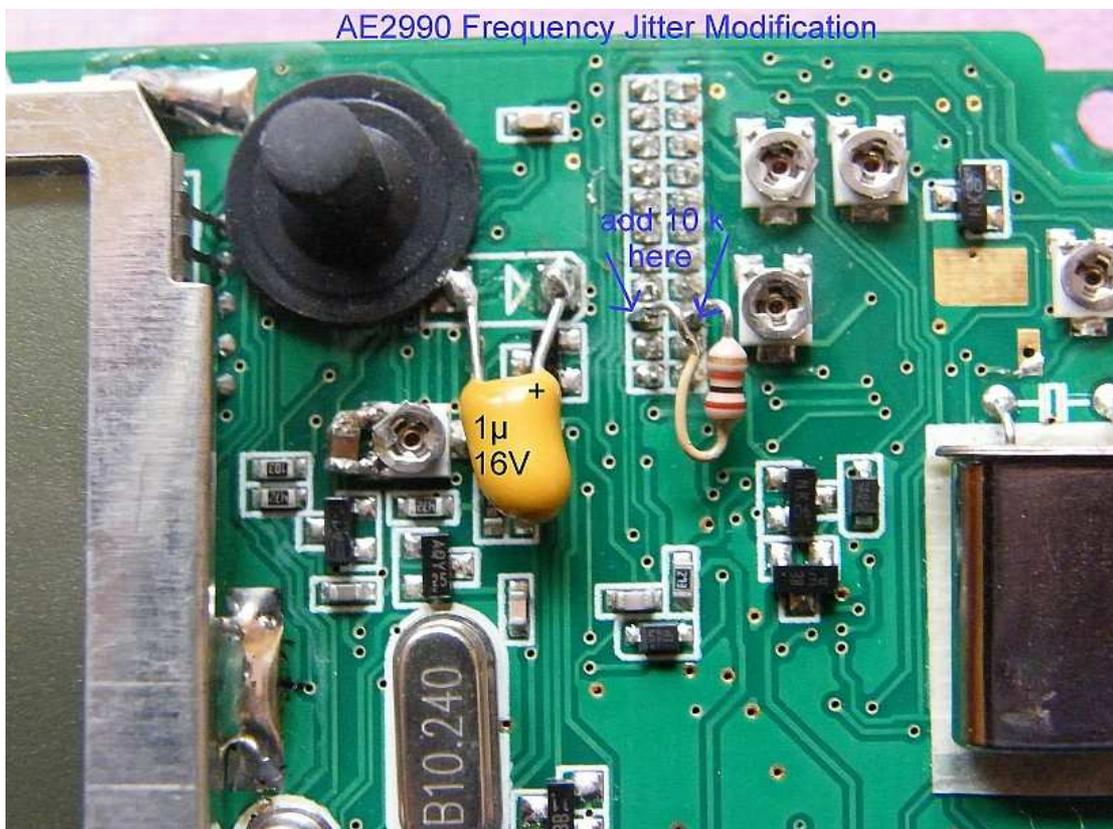
Users reported that units from first production lot show more or less a “frequency jitter” effect during strong SSB modulation. The problem occurs as frequency shift of about 100-200 Hz especially if users produce whistle tones into the microphone during the first 10..20 milliseconds of the tone duration. Distant stations report that the tone is not constant and becomes ok later.

Cause: A negative feedback from rising output power with SSB modulation can cause a short time frequency shift reaction of the VCO. The PLL and phase comparator circuits then try to compensate the VCO Varicap voltage.

1. Change the original **SMD standard capacitor 2.2 µF** into a **Tantalum capacitor of 1µF** capacity (yellow on above photo)

2. Additionally the effect can be further reduced by **adding an additional resistor 10 kOhm** parallel to the PCB plug contacts of the third row (seen from bottom). (Info: these contact points connect to R 203 on main board).

Because this additional resistor may cause longer lock-in periods on lowest and highest 400 CH band frequencies, we do not recommend this modifications to users who should use this configuration. In that case we recommend to check the lock behaviour with and without resistor.
